# Manhole Inspection Summary

Manhole # S27K\_\_020MH

**Location** Address: **841 Ramsey St**

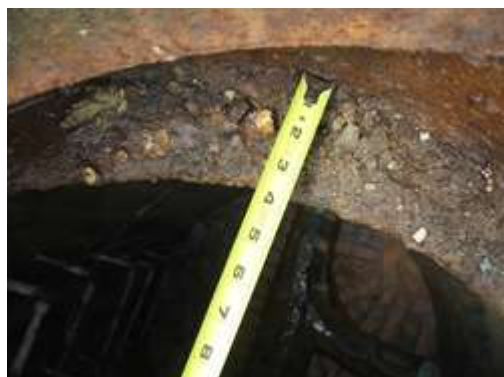
Defect 7

Offset: **4.5** (in.)

frame offset 4.5"

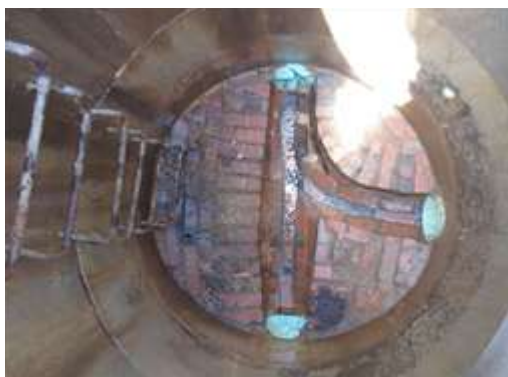
Defect 5

Count: **7** Missing: **0** ☒ **Corroded**

Corroded Steps

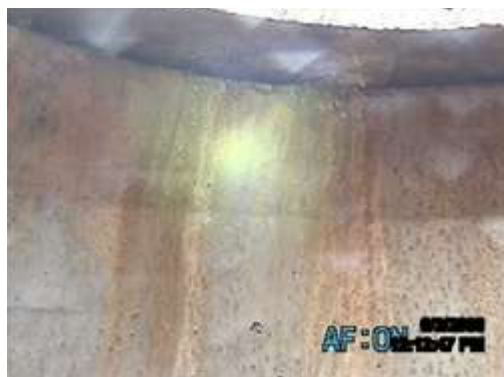
Defect 4

Infiltration: ☐ None ☒ **Joint** ☐ Cracks ☐ Mortar ☐ Roots ☐ Wall

active infiltration under  
offset-frame-chimney connect

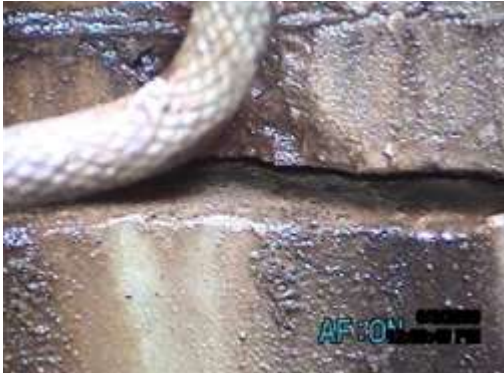
### Defect 1

Infiltration: ☐ None ☒ **Joint** ☐ Cracks ☐ Mortar ☐ Roots ☐ Wall

corbel barrel connect infiltration

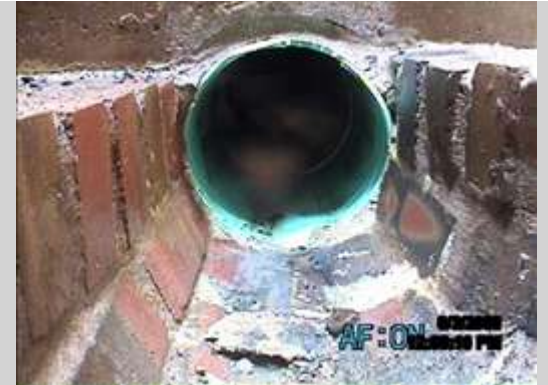
12 O'Clock Outflow

8 in. Circular Gravity Sewer  
Pipe Out @ 12 O'Clock

Infiltration: **None** Pipe Seal Cond: **Sound**

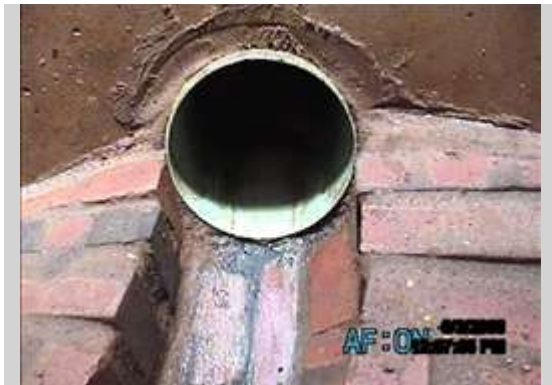
4 O'Clock Inflow

8 in. Circular Gravity Sewer  
Pipe In @ 4 O'Clock

Infiltration: **None** Pipe Seal Cond: **Sound**

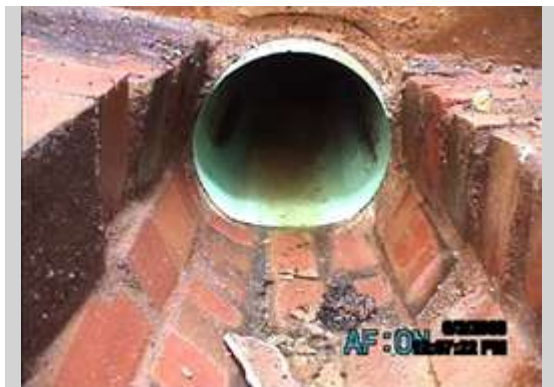
6 O'Clock Inflow

8 in. Circular Gravity Sewer  
Pipe In @ 6 O'Clock

Infiltration: **None** Pipe Seal Cond: **Sound**
